# Manhole Inspection Summary

Manhole # S33O1\_003MH

Insp Date: **2/4/08 12:32 PM**

**Location** Address: **Gulfport Dr.**

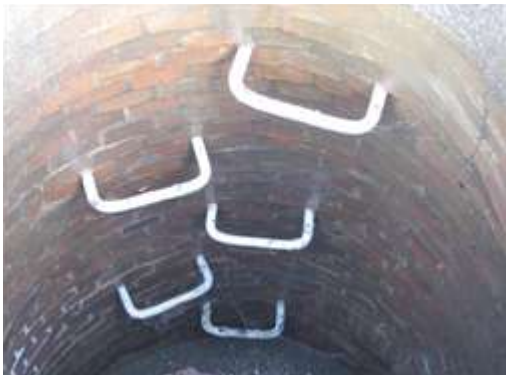
Steps

**Steps** Count: **5** Missing: **0** ☐ Corroded

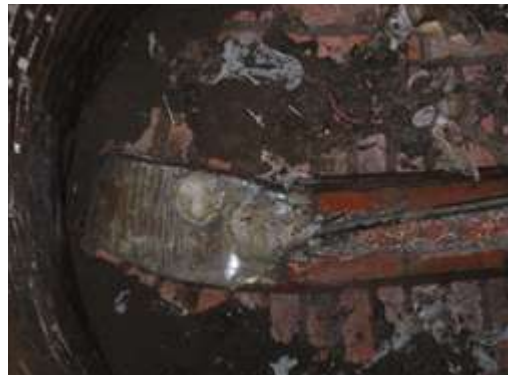
Defect 2

Condition: ☐ Sound ☐ Cracked ☐ Root Intrusion ☐ Deteriorated ☐ Leaks ☒ **Debris**

Bench/channel

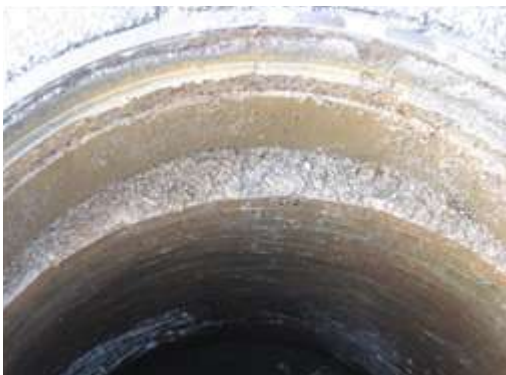
Defect 1

**Frame** Offset: **2.5** (in.) Condition: ☒ Sound ☐ Cracked ☐ Leaks

Frame offset

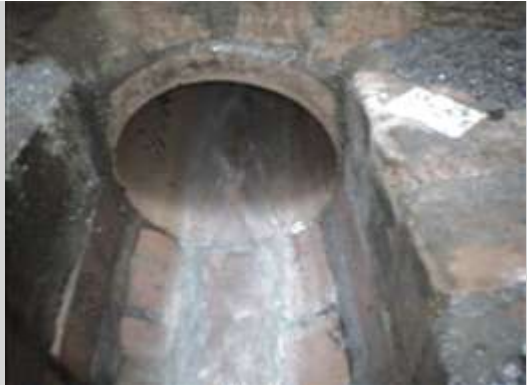
12 O'Clock Outflow

Pipe Height: **8.4** (in.) Rod and Bar (Angled)  
Pipe Material: **Clay** ☐ Pipe Lined  
Invert Depth: **10.35** (ft.) Flow Characteristics: **Fast**  
Deposits: ☒ None ☐ Mud ☐ Sludge ☐ **Debris** ☐ Grease  
Silt Depth: (in.) Deposits Extent:  
Infiltration: **None** Pipe Seal Cond: **Sound**

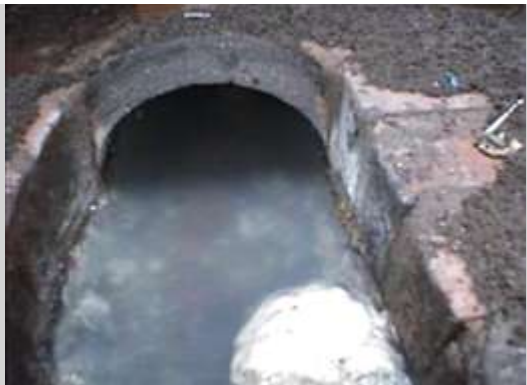
6 O'Clock Inflow

Pipe Height: **8.4** (in.) Rod and Bar (Angled)  
Pipe Material: **Clay** ☐ Pipe Lined  
Invert Depth: **9.95** (ft.) Flow Characteristics: **Slow**  
Deposits: ☐ None ☐ Mud ☐ Sludge ☒ **Debris** ☐ Grease  
Silt Depth: **3** (in.) Deposits Extent: **Light**  
Infiltration: **None** Pipe Seal Cond: **Sound**
